**AFFECTED VEHICLE****MAKE FORD****MODEL TRANSIT****VERSION 2.2 TDCi (P8FA) 63 KW 85 HP 2198 Cm3**

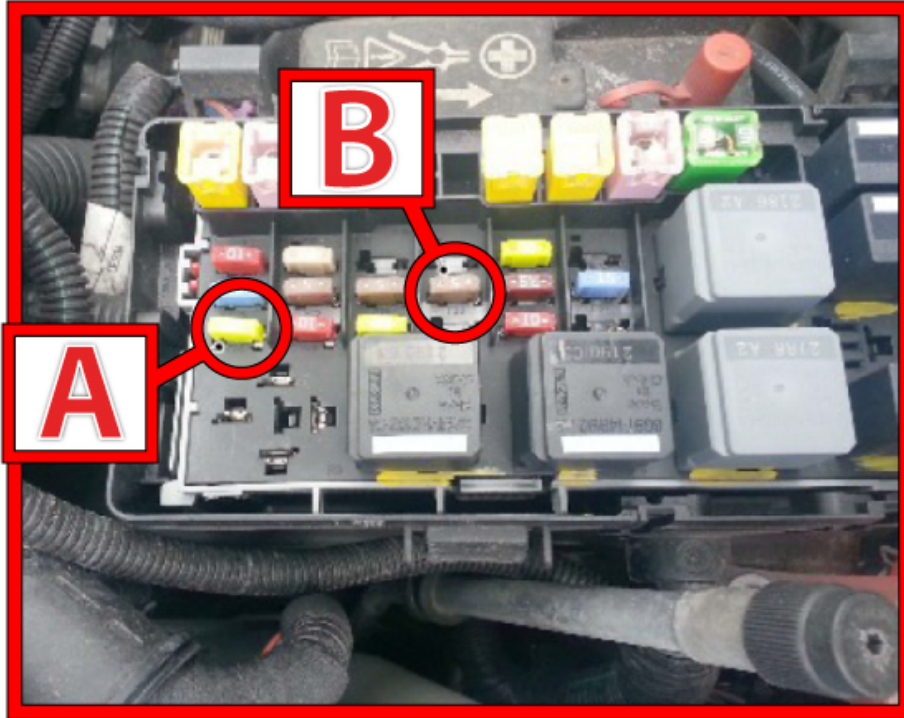
IMAGE 1:

- Due to overheating of the fuel vaporiser glow plug, the 20 Amp F32 fuse blows. (YE) of the glow plug auxiliary heater located in the fuse and relay box (EJB).
- Due to overheating of the fuel vaporiser glow plug, the 5 Amp F29 fuse blows. (BR) of the glow plug monitor located in the fuse and relay box (EJB).

See image 1:

A - 20-amp yellow F32 fuse located in the EJB fuse and relay box.

B - 5-amp brown F29 fuse located in the EJB fuse and relay box.

- Check the condition of fuses F32 (20 Amp yellow. See image 1-A) and F29 (5 Amp brown. See image 1-B) in the fuse and relay box (EJB).
- Replace the affected fuses with new ones.

NOTE: If any of the described fuses (F32 and/or F29) blow/s again, replace the fuel vaporiser glow plug.

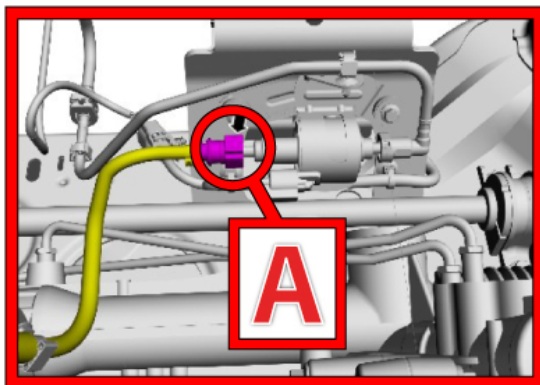
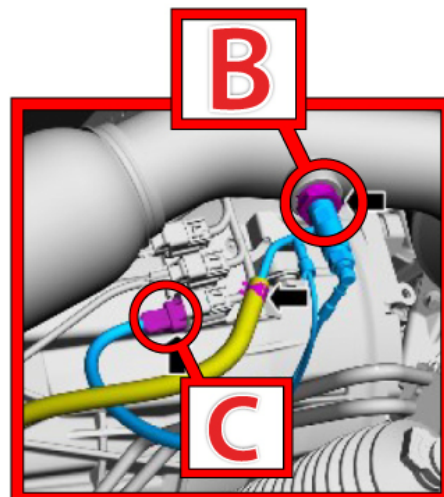
IMAGE 2:

See image 2:

A - Quick connection of the vaporiser fuel supply line.

B - Vaporiser connection. Tighten to a torque of 48 Nm.

C - Glow plug connector of the fuel vaporiser.

- Lift the vehicle.
- Disconnect the fuel supply hose from the vaporiser by pressing the quick coupling locking device (See image 2-A).

- Measure the resistance of the multimeter by touching both test terminals and write down the resulting value (A value).
- Disconnect the fuel vaporiser connector (See image 2-C).

- Replace the fuel vaporiser with a new one if it takes for the pressure more than 2 seconds to reach 0 bar.
- Tighten the new vaporiser to a torque of 48 Nm (See image 2-B).
