**AFFECTED VEHICLE****MAKE JAGUAR****MODEL XF****VERSION 3.0 D (AJV6D) 202 KW 275 HP 2993 Cm3**

**P22D2-77** - Turbocharger turbine inlet valve stuck open. Command position is not reachable.

**P22D3-77** - Turbocharger turbine inlet valve stuck closed. Command position is not reachable.

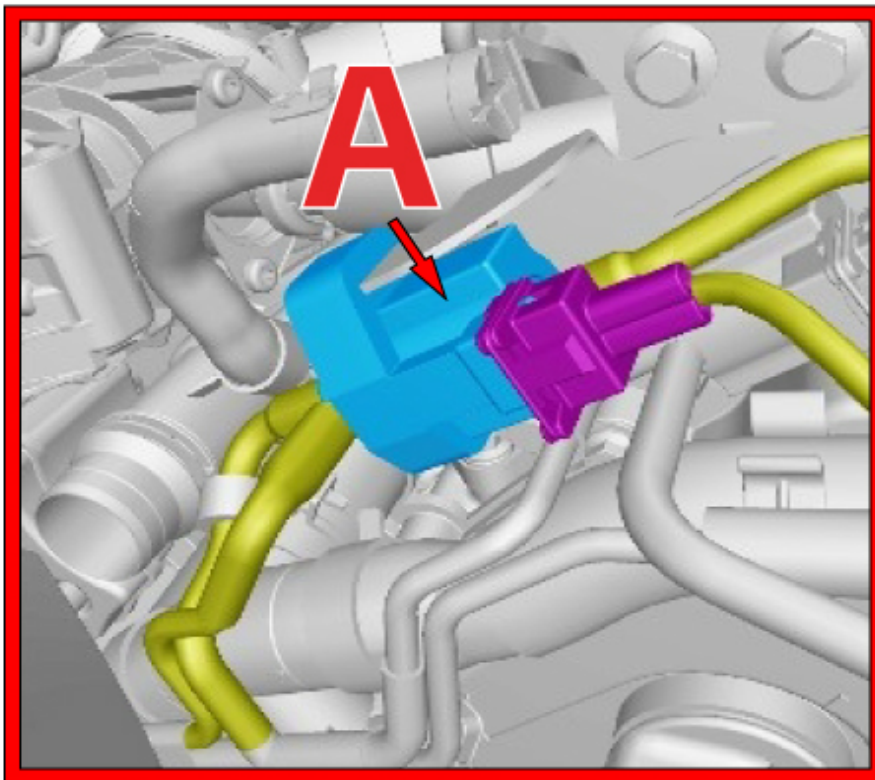
**IMAGE 1:**

A - Turbocharger vacuum valve.

- Check and verify the correct condition of the wiring of the secondary turbocharger vacuum solenoid valve.
- Check the vacuum system (check for broken, disconnected or incorrectly connected tubes).
- Replace the secondary turbocharger vacuum valve (See image 1 - A) if the condition of the vacuum system and the condition of the wiring is correct.

- Check and verify the correct condition of the wiring of the secondary turbocharger vacuum solenoid valve.
- Check the vacuum system (check for broken, disconnected or incorrectly connected tubes).
- Replace the secondary turbocharger vacuum valve (See image 1 - A) if the condition of the vacuum system and the condition of the wiring is correct.
- Clear the fault codes recorded in the control unit using the diagnostic tool.
- Perform a road test.
- Perform a second fault code reading on the engine control unit (ECU) using the diagnostic tool and confirm that the fault codes mentioned in the field symptoms of this bulletin are NOT recorded.
