**AFFECTED VEHICLE****MAKE** DACIA**MODEL** DUSTER**VERSION** 1.5 dCi (K9K 892) 66 KW 90 HP 1461 Cm3

DTC148072 - P1480 72 - Exhaust shut-off valve.

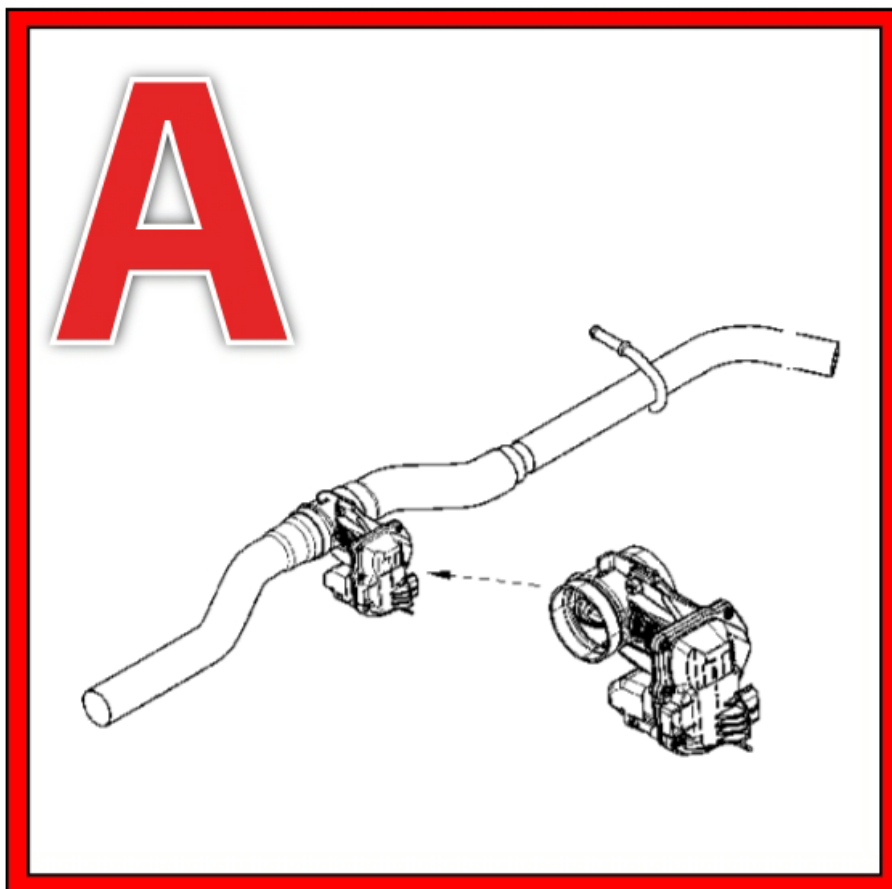
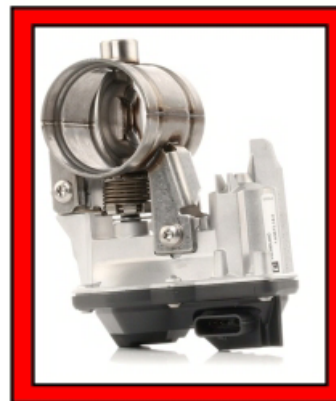
IMAGE 1:

A - Location of the exhaust gas recirculation (EGR) valve.

- Check the exhaust gas recirculation (EGR) valve reference.
- Replace the exhaust gas recirculation valve (EGR) with a modified version, if its reference number is: **147B07424R**.

- Reprogramme the engine control unit with updated software if the exhaust gas recirculation (EGR) valve reference number is: **147B08010R**.
- Clear the fault codes recorded in the control unit using the diagnostic tool.
